Manhole Inspection Summary

Manhole # S15II1033MH

Location Address: **4229 ROLAND VIEW AVE**

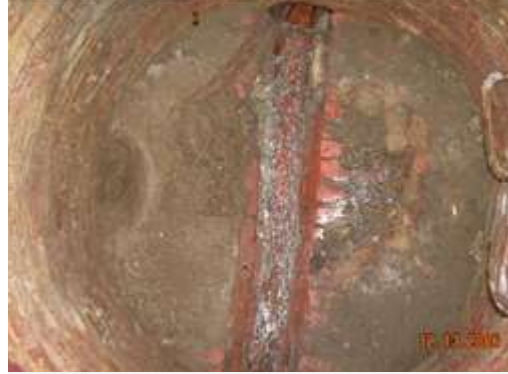
Top View

Bench ☒ Exists Material: **Brick** ☐ Parged ☒ **Debris** (not Condition related)

Condition: ☐ Sound ☐ Cracked ☐ Root Intrusion ☐ Deteriorated ☐ Leaks ☒ **Debris**

Evidence of surcharge - Bench debris.

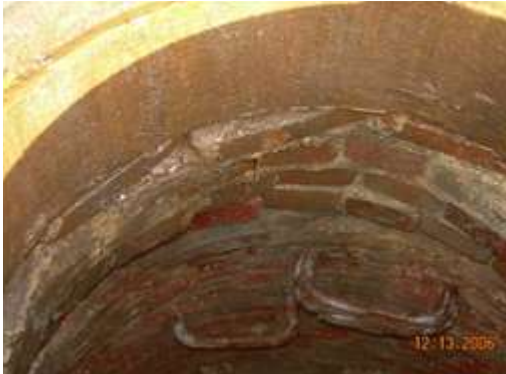
Defect

Frame Offset: **1** (in.) Condition: ☐ Sound ☐ Cracked ☒ **Leaks**

Infiltration: ☐ None ☒ **Joint** ☐ Cracks ☐ Mortar ☐ Roots ☐ Wall

Frame leaks. Adjustment deterioration and infiltration.

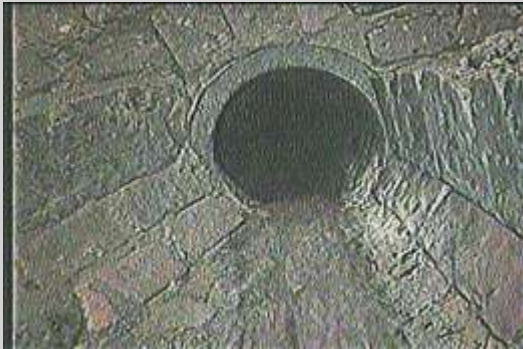
8 in. Circular Gravity Sewer Pipe Out @ 12 O'Clock

Condition: ☐ Sound ☐ Cracked ☐ Root Intrusion ☒ **Deteriorated** ☐ Leaks ☐ Debris

Channel deterioration.

Infiltration: **None** Pipe Seal Cond: **Cracked**

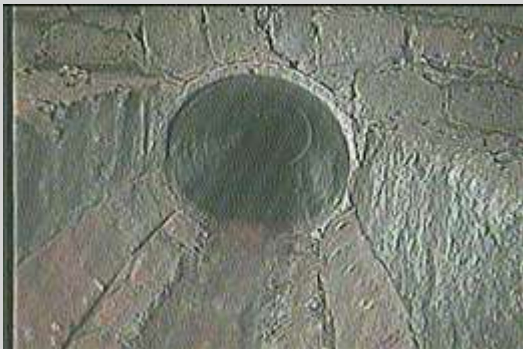
8 in. Circular Gravity Sewer Pipe In @ 6 O'Clock

Infiltration: **Evidence** Pipe Seal Cond: **Cracked**

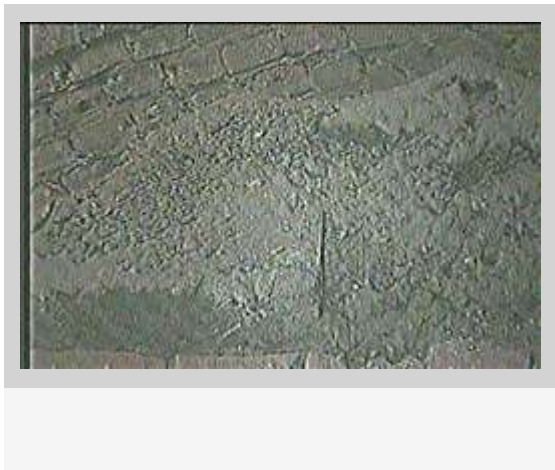
Pipe In @ 9 O'Clock

Comments **The I9 appears to be an abandoned.**

Deposits: ☐ None ☒ **Mud** ☐ Sludge ☐ Debris ☐ Grease

Silt Depth: **0** (in.) Deposits Extent: **Heavy**

Connects To: **Stub connection / abandoned**
